# **WATER DAMAGE ASSESSMENT**

**Massachusetts Gaming Commission  
101 Federal Street, 12<sup>th</sup> floor  
Boston, Massachusetts**

Prepared by:  
Massachusetts Department of Public Health  
Bureau of Environmental Health  
Indoor Air Quality Program  
August 2019

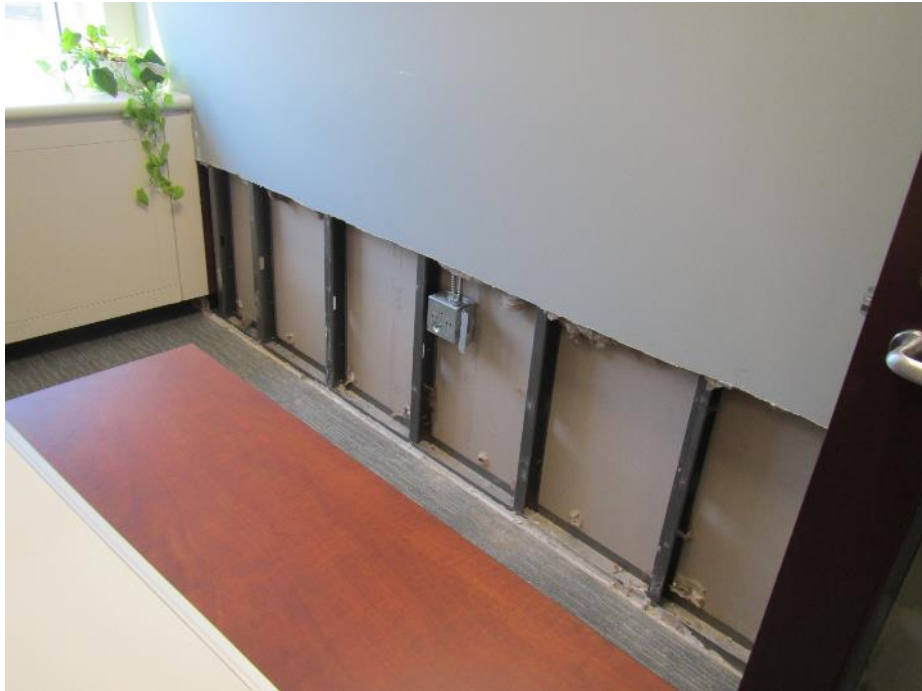
**Picture 1**

- Use of fans to accelerate drying of carpeting and gypsum wallboard (GW);
- Removal of areas of GW, with holes drilled in some remaining wallboard to accelerate drying (Picture 1);
- Removal of coving from impacted walls (Picture 2)

- Wallboard was removed and had holes cut in its base to allow for drying in the affected areas (Picture 1). Coving was also removed from most affected walls (Picture 2).

**Gypsum wallboard cut away from wall with holes drilled in opposite side**

- a. Inspecting and cleaning the area above moistened ceiling tiles;
  - b. Cutting out and replacing areas of GW that continue to be moistened 48 hours after the flood;

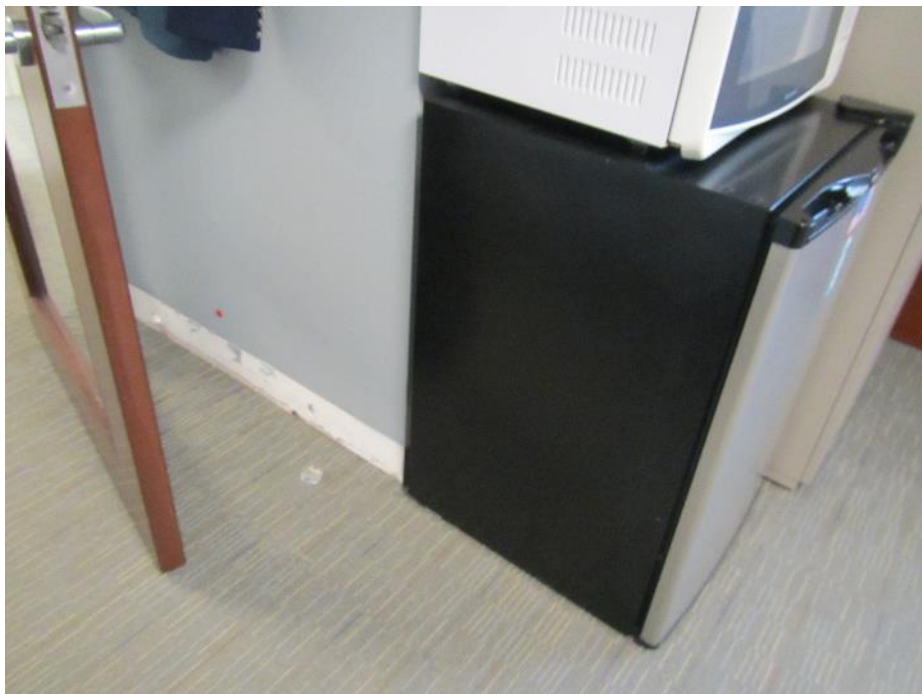
**Picture 2**

- Furniture and items including porous items (e.g., boxes) were observed remaining on the floor in the affected area (Pictures 2 and 4). Some of the boxes appeared water-damaged. These items can prevent walls/floors from drying and can prevent access for cleaning and testing. Furthermore, porous items can become colonized with mold.

**Coving removed from wall, note furniture against wall**

1. Move or remove any items and furniture from the floor and away from walls in the affected areas to inspect underneath and behind them for additional water damage.

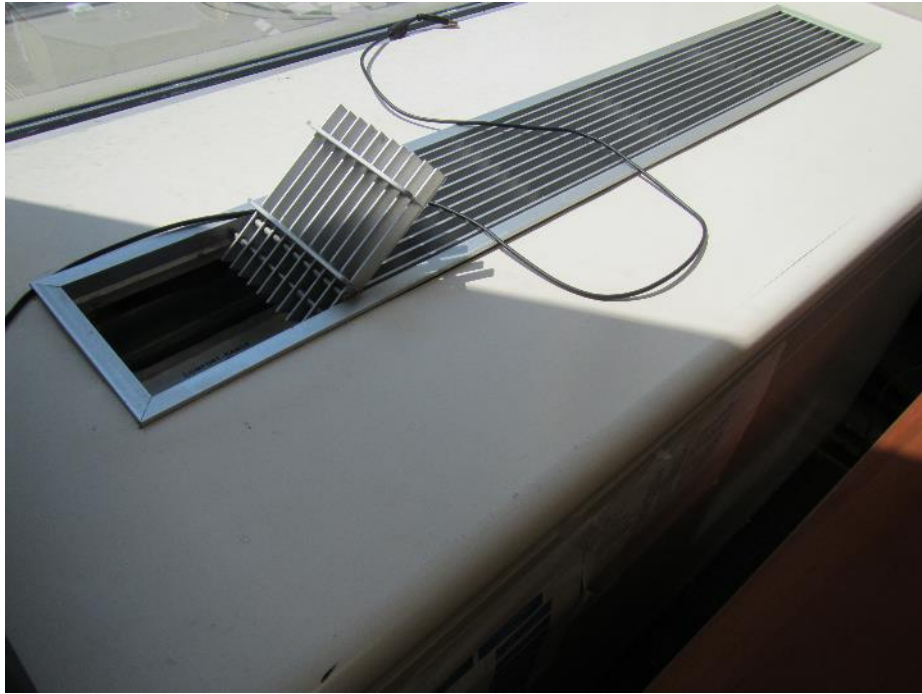
**Picture 3**

- Damage was observed to fan coil unit housing covers, which appear to be made of plywood with a heavy layer of paint (Picture 3). Additionally, some were still wet at the time of the visit as shown by moisture measurements. These pieces should be replaced since water-damaged plywood can be an ongoing source of odors, particularly if it is in the airstream of air circulation equipment.

**Fan coil unit cover, found to be moist**

- c. Replacing the covers of all damaged fan coil units such as the one shown in Picture 2. All of these units should be inspected for odors and vacuumed of debris at this time as well.

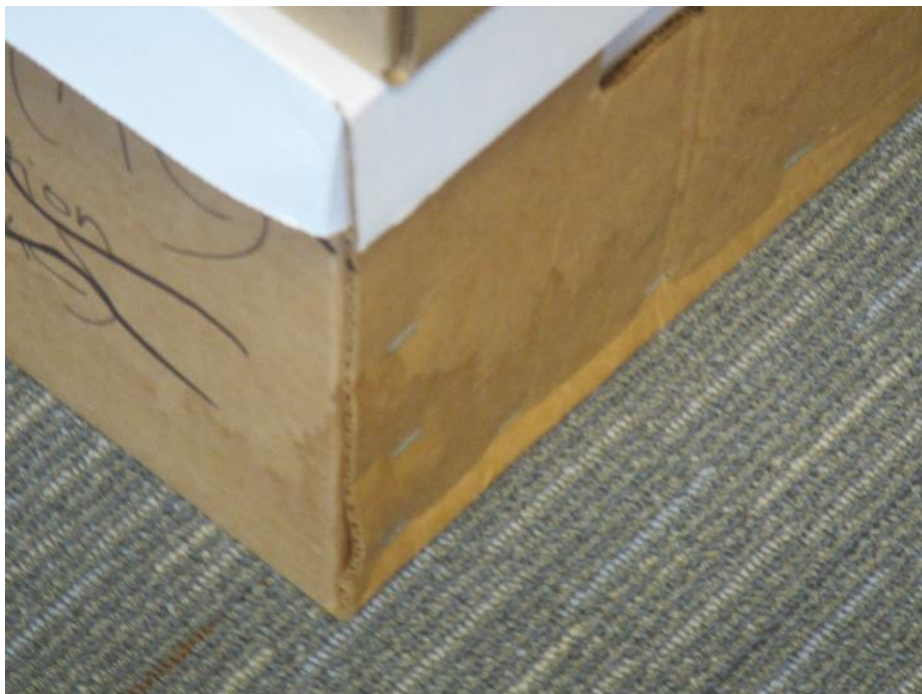
**Picture 4**

**Box on floor in impacted area, note signs of water damage**

2. Water-damaged porous materials such as boxes/papers, laminated tables or other items may need to be discarded if they show signs of mold colonization such as musty odors.
